Manhole Inspection Summary

Manhole # S21I__007MH

Insp Date: **9/24/07 10:52 AM**

Location Address: **22 FULTON AVE**

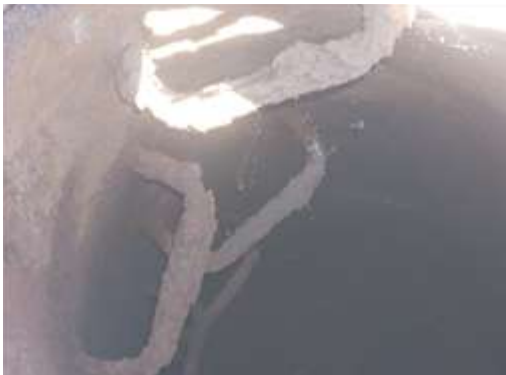
Defect 3

Count: **6** Missing: **0** ☒ **Corroded**

CORRODED STEPS

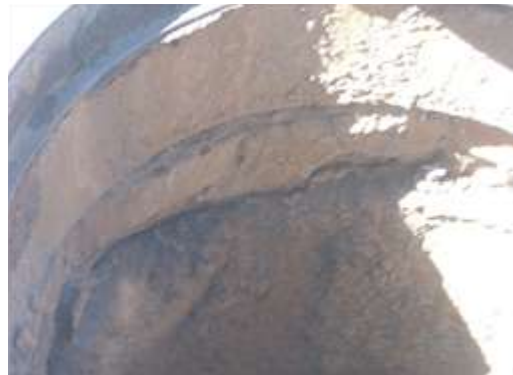
Defect 2

Condition: ☐ Sound ☐ Cracked ☐ Root Intrusion ☐ Loose Brick ☒ **Deteriorated**

DETERIORATED CHIMNEY

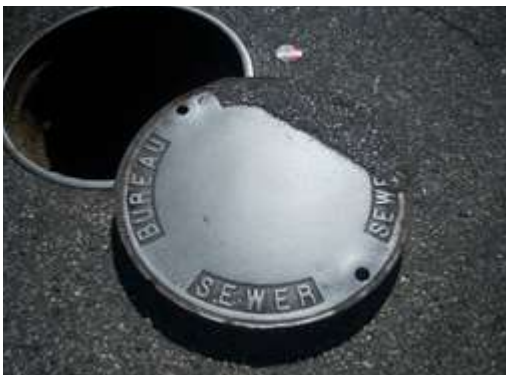
Defect 1

Condition: **Worn**

WORN COVER

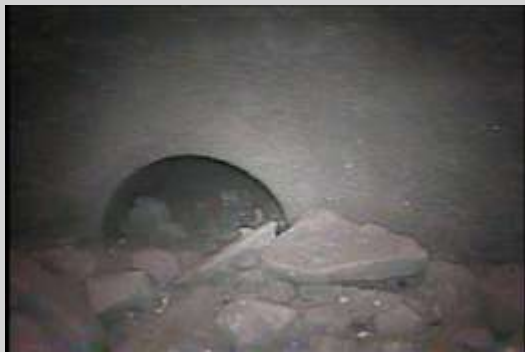
12 O'Clock Outflow

8 in. Circular Gravity Sewer
Pipe Out @ 12 O'Clock

Deposits: ☐ None ☐ Mud ☐ Sludge ☒ **Debris** ☐ Grease

Silt Depth: **3** (in.) Deposits Extent: **Medium**
